GEOTECHNICAL FEATURES OF HISTORICAL ARCHITECTURAL MONUMENTS OF CENTRAL ASIA

A.Zh. Zhussupbekov¹, A. Issina², Y. Iwasaki³, Sh. Kenjaev⁴, I. Usmankhodjaev⁵

Abstract: In this paper geoenvironmental problems of the historical cities of Central Asia are considered, climatic, geotechnical, hydrogeological characteristics of the studied objects, their constructive decision and the analysis of deformations of elevated and underground construction designs are provided. Main reasons for deformations of monuments of architecture of Central Asia: uneven rainfall of soil of the basis in the most overloaded sites of designs of the building; seismic influences; violation of temperature moisture conditions and moisture; anthropogenous influence (especially notable in the historical cities of Samarkand and Bukhara where monuments of architecture are influenced by vibrations from traffic). In the paper the offered observation method of monuments of architecture of Central Asia and results of observation of the mausoleum Arystan-Bab and a mosque and minaret Kalon for 2014 is described.

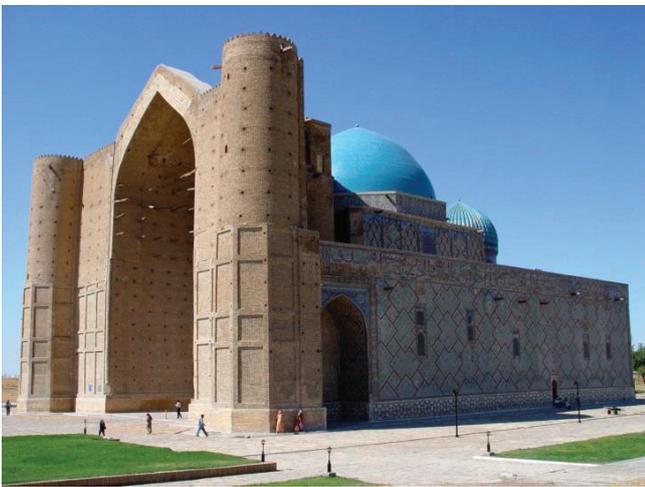
Figure 1. The Mausoleum of Hodge Ahmed Yassavi.

Deformations. Due to the lack of emergence of essential deformations on a monument to the first cycle it wasn't given due consideration though at this moment there was a deep soaking of soil and the basis of the foundations of monuments of the complex. The second cycle of rise in level of ground waters caused already external deformations of the building of a monument, in December, 1982 there was a destruction of the top restoration number of stalactites of a dome of the Main Hall - Kazanlyk.

In 1993 the technology of jet cementation of soil was applied to strengthening of the basis of a monument by the Turkish company. Strengthening and the device of piles was carried out to two stages. At the first stage of work were carried out for walls to 2 m. At the second stage strengthening of the basis of walls up to 4 m thick was made. Total length of a pile is about 15 m. Thus, the support of all construction through piles on thickness of solid soil is reached.

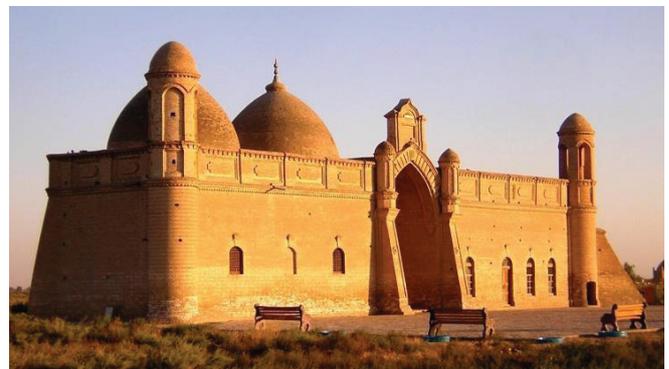
Figure 2. The Mausoleum of Arystan-Bab.

Deformations. In a laying of walls cracks on all facades are noted. During observation it is established that width of disclosure of cracks makes from 0,1 to 2 mm. In a place of interface of a minaret to a wall (a northeast facade) the crack reaches 2 cm and goes mainly on laying seams. All cracks in a laying come to an end, without reaching a socle. Cracks, generally in places of reduction of thickness of walls settle down. Indoors tombs № 1 are noted the deformations in a laying menacing to safety of a construction. These are cracks and smashing of a brick in a laying of basic part of arches, split of a brick in places of support of angular arches in northeast and northwest walls. In a northeast wall of a crack in a laying of basic part of arches have extent to 2 m.

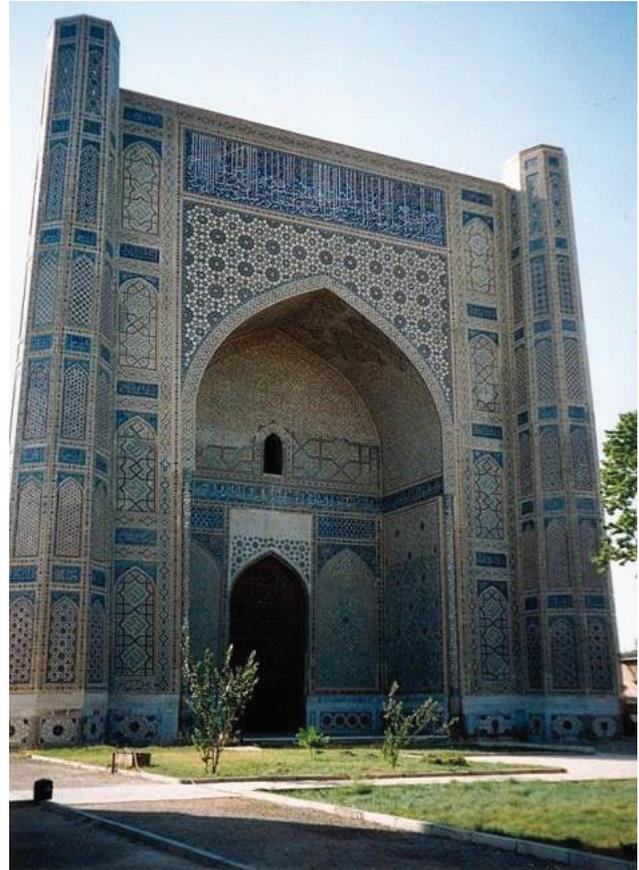
Figure 4. The Bibi-Hanym Mosque.

Deformations. In a body of old layings and a minaret traces of inclined cracks are visible. It means that before destruction the minaret was strongly rejected from a portal. Existence of cracks in the central dome part of the Big mosque is noted.

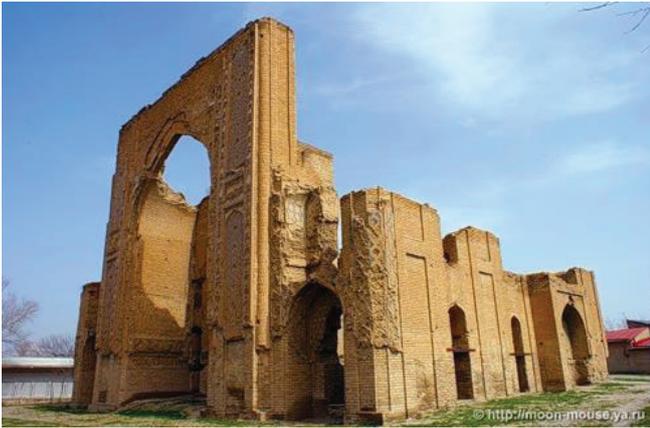
Figure 5. The Ishratkhona.

Deformations. The building of a monument is strongly destroyed and many elements are bared. The design of an underground crypt is executed from the flat arch leaning on massive side support. Support of the arch aren't connected with the bases of the main building that gives it the chance independently to be deformed irrespective of building rainfall. In 1903 the dome and a drum of the central room failed, and in 1904 the remains of a drum and the top parts supporting its arches finally collapsed. The main reason for long destruction of vaulted and arch designs is

connected with gradual decrease in durability of material in the most loaded basic parts and destruction of integrity of designs.

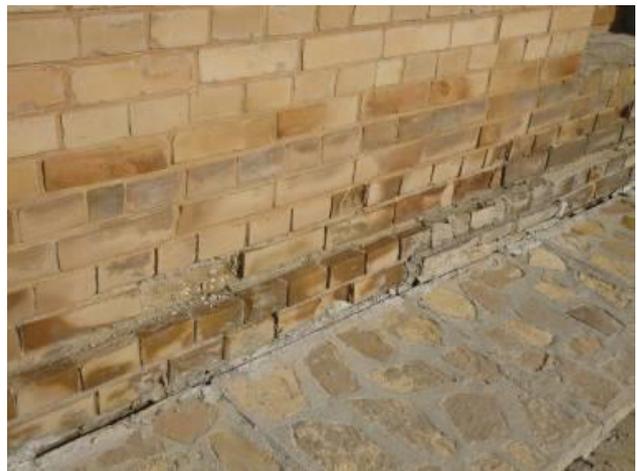
Walls. In general bricks of walls are in a satisfactory condition. Aeration of separate bricks on facades, and also seams on buttresses, in the lower and top parts of walls (parapet), in a laying of a northern minaret is noted (Figure 6).

Figure 6. Destruction of Separate Bricks in a Laying of a Socle and Walls of the Mausoleum Arystan-Bab.

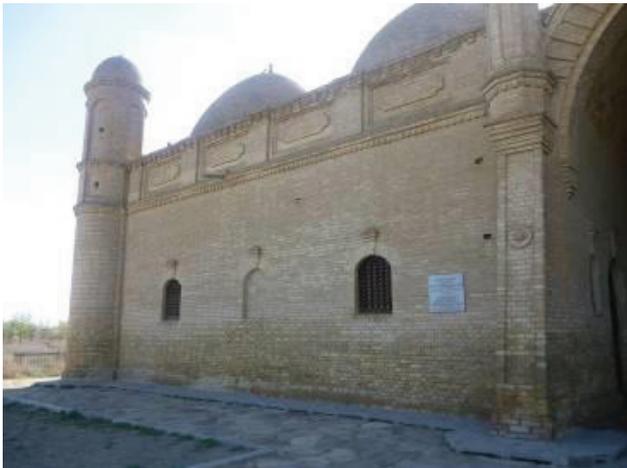
On a surface of a bricklaying of walls of northwest, southwest and northeast facades salt spots (Figure 7) are noted. Walls are moistened in these parts on 1,5-2 m.

Figure 7. Moistening of the Lower Part of a Northeast Facade of the Mausoleum Arystan-Bab.

Blind area. Round the mausoleum the blind area is executed from a stone-plitnyak on cement mortar. As cement mortar interferes with moisture evaporation, the blind area round a construction was sorted on width of 40-50 cm.

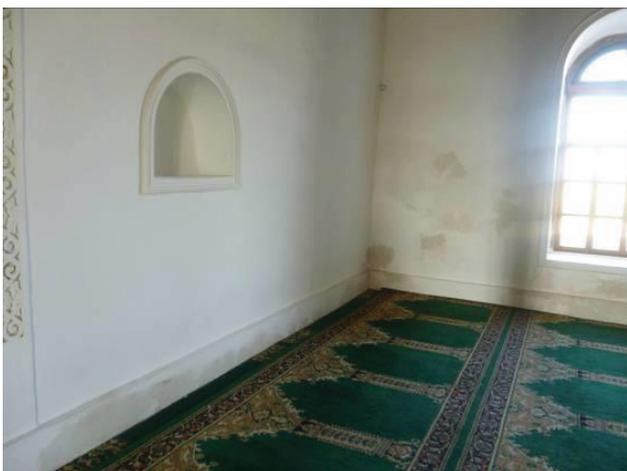
Figure 8. The Interior of Mausoleum Arystan-Bab.

The laying of domes and turrets is covered with lichens. In an interior of a mosque moistening of a blanket of plaster is noted. Floors are carpeted, thus carpets in a half-baked state that testifies to moistening of plates of a floor of a mosque (Figure 8).

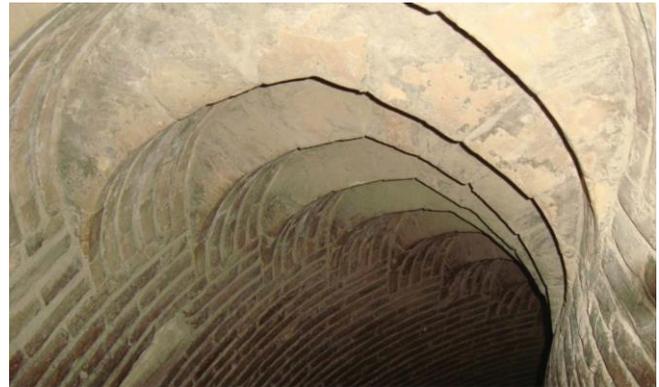
Figure 9. The Arch of the Spiral Staircase of the Minaret Kalon.

• the ladder - a brick ladder leans on a trunk and external walls of a minaret. A satisfactory technical condition, steps didn't lose the bearing ability. Deformations and destructions it isn't observed.

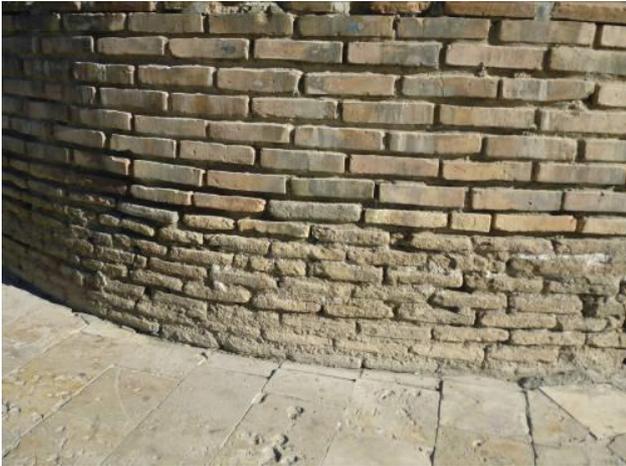
On perimeter of walls are observed, from outer side the aeration of solution and the humidified sites in internal walls extending from floor level to 1,8-2,0 m on height (Figure 10)

Figure 10. Aeration of Solution in Bricklaying Seams of Mosque Kalon.
