## INVESTIGATION OF FAILURE OF RIVERBANK PROTECTION STRUCTURE: A CASE STUDY IN LONG AN PROVINCE, VIETNAM

*Pham Ngoc Thinh, Dang Van Phu*

Thuyloi University, 175 Tay Son, Dong Da, Hanoi, VIETNAM

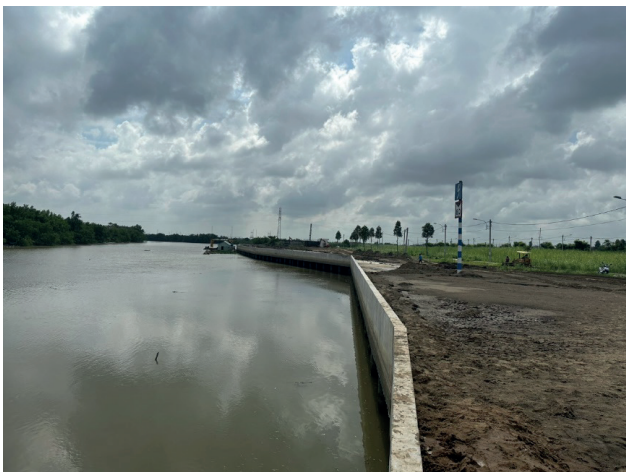
As shown in Figs. 3 and 4, the Long Hau embankment began to show signs of failure soon after completion. Major issues included a displacement of approximately 20cm toward the river, visible cracks in the concrete piles, and settlement of the compacted sand layer behind the wall. These issues raised concerns about the long-term stability and resilience of the structure and posed potential risks to adjacent infrastructure and the ecosystem if not addressed promptly.

*Figure 3. Settlement of the compacted sand layer after construction completion*

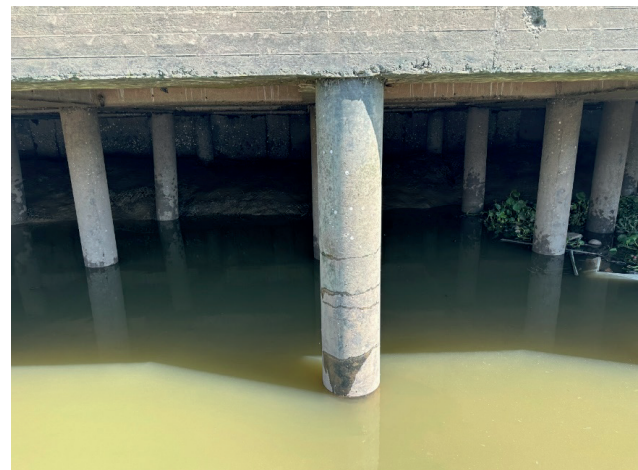
*Figure 4. Cracks on piles*

These failures may be due to design or construction method deficiencies. The presence of cracks may indicate that the piles are not sufficiently resistant to surcharge load and lateral force. Similarly, lateral displacement towards the river may indicate a deviation in the safety system or a lack of force components in the calculation. The settlement of the sand layer behind the wall is due to uneven compaction. Solving these problems requires a comprehensive analysis of design and construction factors, focusing on soil interactions and material selection. Therefore, a safety assessment analysis for this structure is

required to find the main causes that may lead to displacement and subsequent pile cracking.

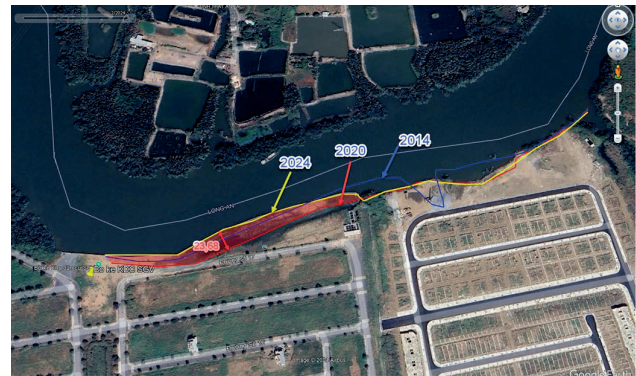
Fig. 5 shows the clear transformation of the regional riverbank from 2014 to 2024. The colored contours represent the positions of the riverbank in a specific timeline, such as 2014 (blue line), 2020 (red line), and 2024 (yellow line). These lines represent the progress of the riverbank movement through each stage. The 2014 riverbank is located close to the riverbed, representing the initial state of the riverbank before being greatly impacted by natural or human factors. The blue line shows that the extent of the riverbank remains relatively stable, without significant changes, indicating that the level of erosion or artificial intervention is still very limited. By 2020, the riverbank changes became more evident as the red line moved toward the landside compared to that observed in 2014. This can be explained by natural erosion or interference from construction and land exploitation activities near the riverbank area. This shift suggests a possible reduction in natural land area and also shows the impact of hydrological or human factors on the topographic structure of the area. The shoreline in 2024 (represented by the yellow line) is currently the newly designed embankment line. Noticeably, the position of the project is about 23.68 m from the shoreline. Choosing the centerline position far from the existing shoreline with this distance can create certain deviations in the calculation of loads and pressures on the embankment, especially the soil pressure from the backfilling foundation (highlighted in red color) after the completion of the project. The observation also shows that the incident

occurred mostly in this area. It might be due to the fact that, during the design process, the impact of the backfilling foundation may not have been considered carefully, leading to the omission or underestimation of important impact forces. Specifically, the earth pressure and displacement of the foundation after backfilling are likely to put great pressure on the embankment, requiring additional reinforcement measures or appropriate structural solutions to maintain the stability of the structure. Therefore, it is necessary to carefully analyze the cause of this incident, from which appropriate solutions can be proposed to reinforce the structure at this location.

*Figure 5. Location of shoreline in 2014 and 2020 and embankment in 2024*

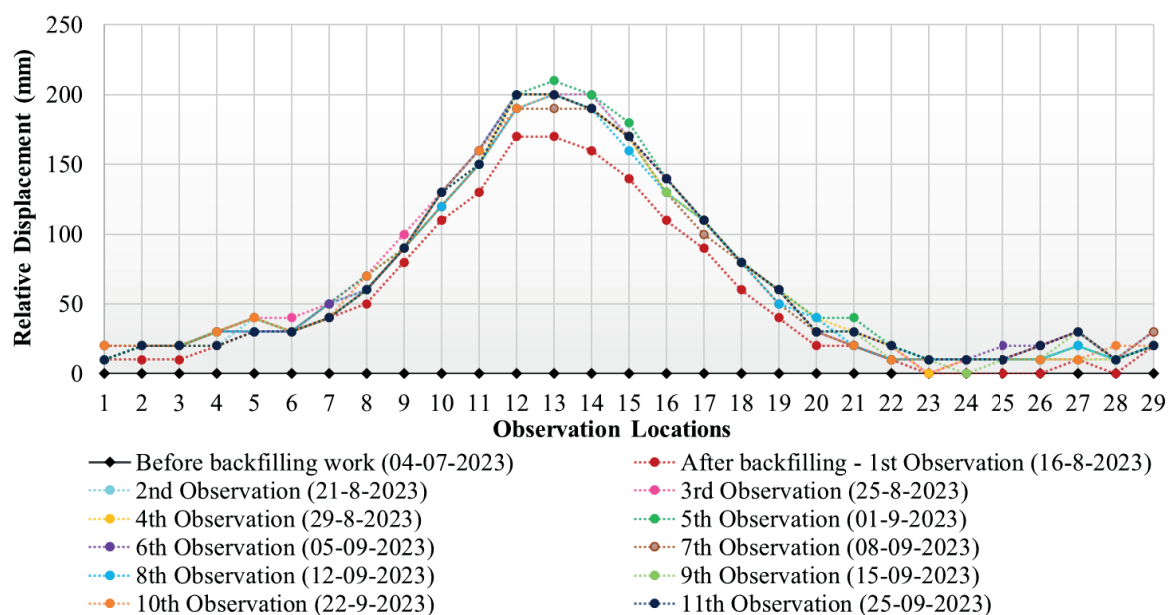
The results collected from the field observation have been summarized and presented in Fig.7. It can be seen that, after the backfilling on August 16, 2023, the project experienced displacement at 29 measurement points for the first observation. Especially at positions 10-16, the displacement value is quite large, about 11-16cm. After that, there were 10 more observations and the displacement value continued to increase to about 20cm for measurement positions 12 and 13. In addition, cracks have gradually appeared on the concrete piles and can cause unsafety for the project. From this, it can be seen that the design

and construction work were not proper when not fully assessing the impact of backfilling on the project. This displacement may be due to horizontal soil pressure as well as the increased load of machinery and equipment during the backfilling process. In addition, the displacement is great at positions 10-16 due to the considerable area of backfilling compared to the other positions. Thus, the impact of the lateral active earth pressure at these positions is more significant. To verify the cause of this problem, numerical simulation analysis needs to be performed, as shown in the following section.

Figure 7. Relative displacement of the riverbank protection structure from the observation

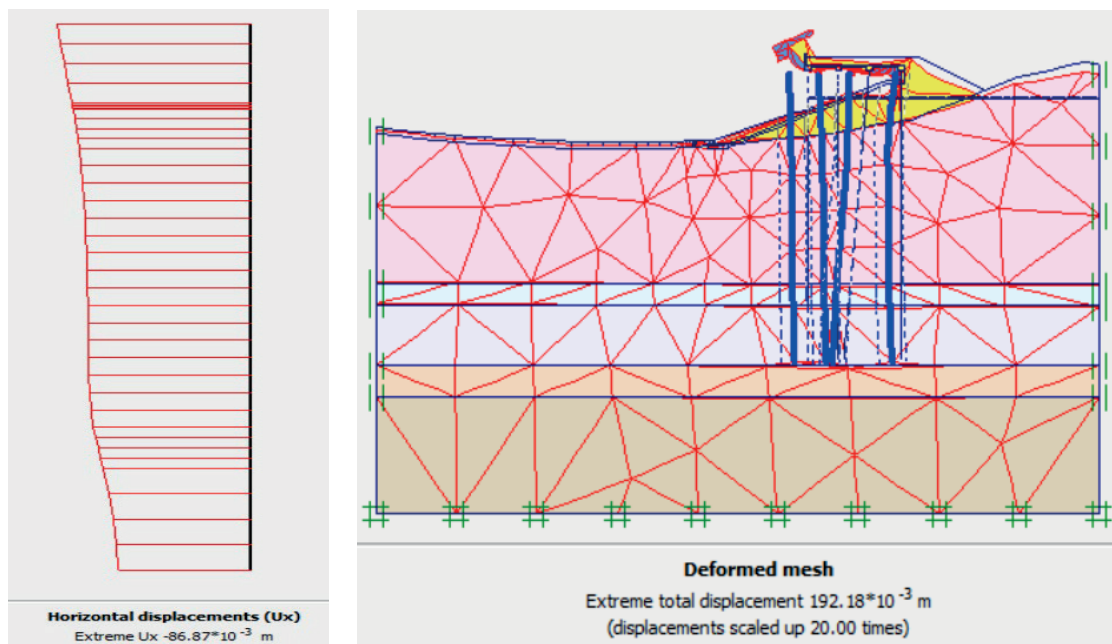
The results of the pile displacement and the overall displacement are shown in Figure 9. It can be seen that the simulation results are quite close to the results from the field observations. The overall displacement value from the numerical analysis, which is 19.2 cm, agrees well with that from the field observation, which is 20.1 cm. The relative difference is only about 4.5%. This proves that the PLAXIS 2D model, with the calibrated material parameters and

boundary conditions, is capable of reflecting the actual conditions in the study area quite accurately. However, a larger error was recorded in the pile displacement, which is 8.7 cm from the numerical analysis compared to 7.5 cm from the field observation. This may be due to the inaccuracy in simulating the connection between the pile and the ground or other nonlinear factors that have not been included in the model.

*Figure 8. Pile displacement and total displacement.*
