THE EXPERIENCE OF THE UNDERGROUND CONSTRUCTION FOR THE COMPLEX OF BUILDINGS ON A SOFT SOIL IN THE CENTER OF ST. PETERSBURG

Mangushev R., Osokin A.

Saint-Petersburg State Architecture and Civil Engineering University (SPbGASU),
Saint-Petersburg, RUSSIA

The experience of the science technical monitoring of the construction of underground parking in a new hotel in the central part of St. Petersburg is given in the article. The parameters of the main underground structures and problems occurred during their construction are presented. The second part of the paper is devoted to the technologies used during the construction of the second stage of the hotel on the area of the dissembled buildings suffered from serious deformation during the construction of the underground parking for the first stage of the hotel.

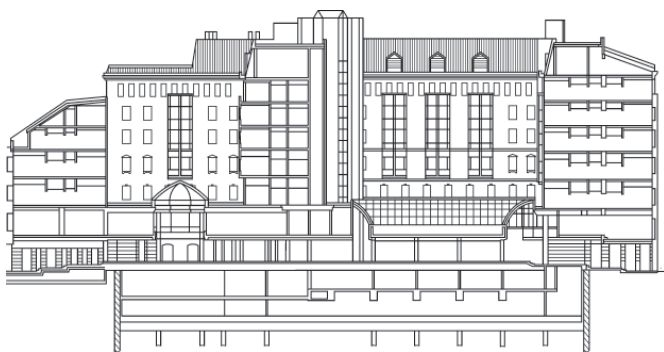
Figure 1. Diagram of underground car parking construction under Nevsky Palace Hotel

In 1992, it was started the reconstruction of the Baltiyskaya Hotel and its remodeling as modern Nevsky Palace Hotel. The high status of the hotel required that an underground car parking was constructed under the main part of the building (Figure 1).

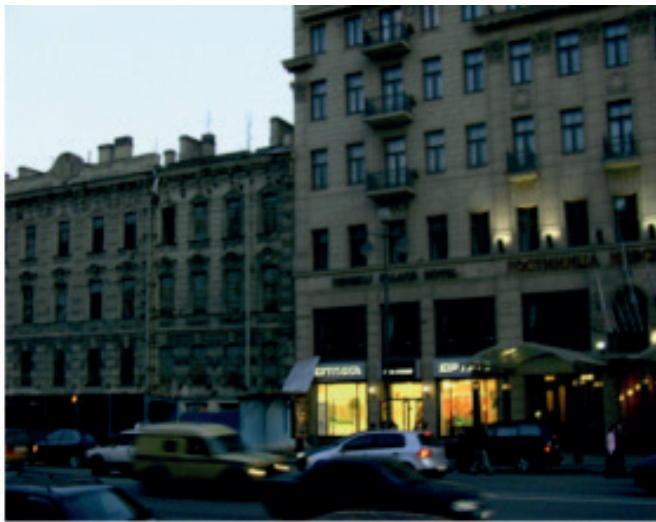
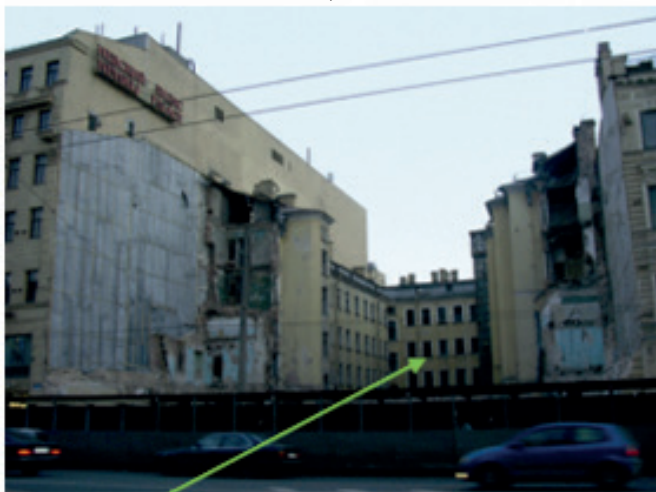
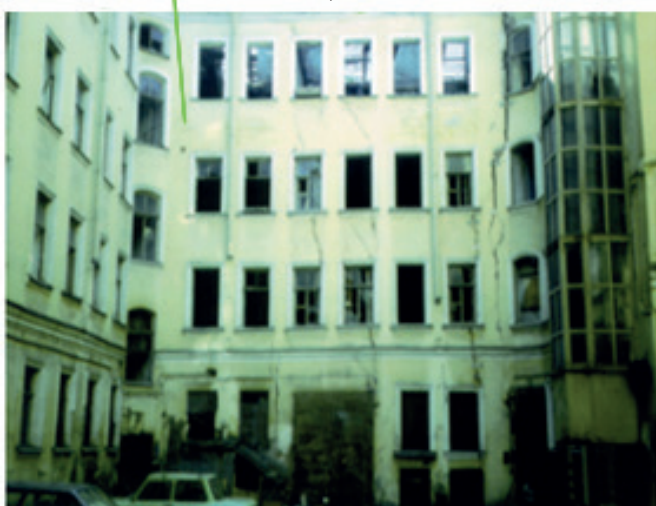
a)

Figure 2. General view of hazardous damages of buildings in the vicinity of hotel in Nevsky Prospekt (a and b) and Stremyannaya Street (c)

The resulting deformations in the envelopes of the surrounding buildings lead to the relocation of the inhabitants of five buildings in Nevsky Prospekt and neighbor Stremyannaya Street (Fig. 2).

Initially, cracks started appearing in the surrounding buildings during the penetration of the first ten pipes. Apparently, it was occurring the consolidation of the bearing layers of the ground bed – fine-grained and silty sand under the foundation beds of these buildings – and the destructuration of the underlying stratified thixotropic sandy loams and loams. In the process of the construction operations, cracks continued opening and new cracks appeared. It might be associated with the destructured water-saturated soils flowing in through the open end of the pipe and then being taken off by an auger.

The most considerable damages occurred in the nearby buildings in the process of constructing "even" piles when drilling in the concrete of the previously constructed piles. Obviously, the vibration action that takes place in drilling of the "primary" piles with special-purpose drilling tools provided with three-cone bits around the perimeter resulted in the thixotropic destructuration of soil and the deterioration of its strength and deformation properties. The soil transformed into the running state and, in the absence of so-called "soil plug", easily got through to the bottom of the borehole, which led to an additional scope of the soil excavation in drilling the boreholes and to the development of wider subsidence trough. These deformations has major effect on the further damage to the masonry strength of the nearby buildings. The settlements of 17 and 13 cm occurred at the nearest points of the foundations of the buildings in Nevsky Prospekt that were located nearby the excavation pit.

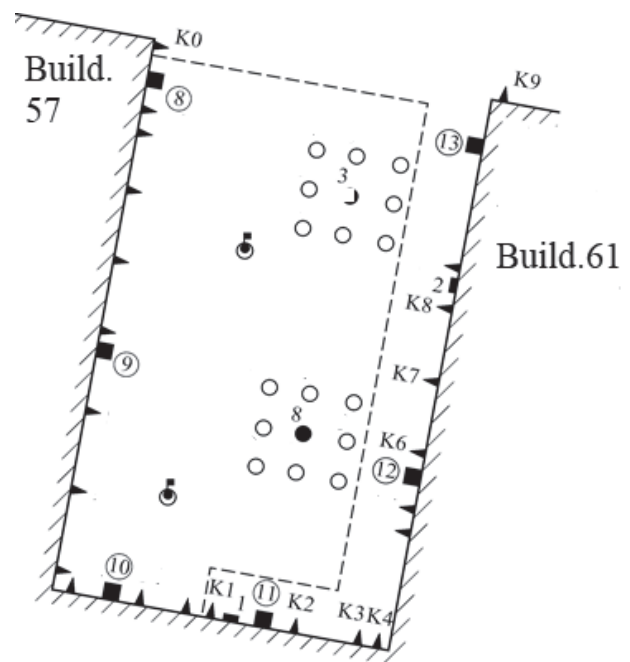
Figure 3. Layout of seismic pickups, settlement benchmarks and tell-tales;

tangent pile method for the underground car parking. Prior to starting the works, the buildings in Nevsky Prospekt and Stremyannaya Street surrounding the two construction sites were surveyed and fitted with tell-tales installed on the existing cracks and with deformation benchmarks for geodetic monitoring. As an example, Figure 3 shows the as-built diagram of the layout of seismic pickups, settlement benchmarks and tell-tales of the monitoring wells to monitor the underground water levels, etc.

In total, observations were carried out twice a week for 95 benchmarks and more than 50 tell-tales. Four wells were used to monitor the underground water levels [1]. When carrying out the works related to underpinning of the foundations and ground beds of the buildings surrounding the construction site by the method of injecting cement grout into the contact area, as well as when constructing the foundations of the drilled cast-in-situ piles, their vibration impact on the enclosing structures of the neighboring buildings was controlled.

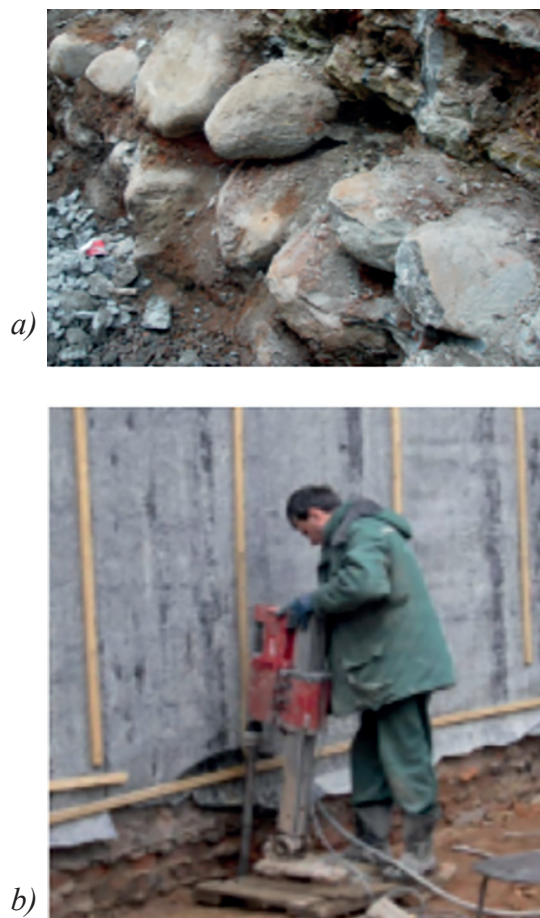
Figure 4. Underpinning of foundations and ground bed of building in Stremyannaya Street (a and b)

The foundation of the neighboring building, which was erected in the beginning the XIX century, were the stone masonry, but the down part of it put granite steening. This was required use injection of the compound cement mortar to provide the continuity of foundation before piling work (Fig. 4a). Figure 4b shows a process of underpinning the building foundations using the Hilty equipment.

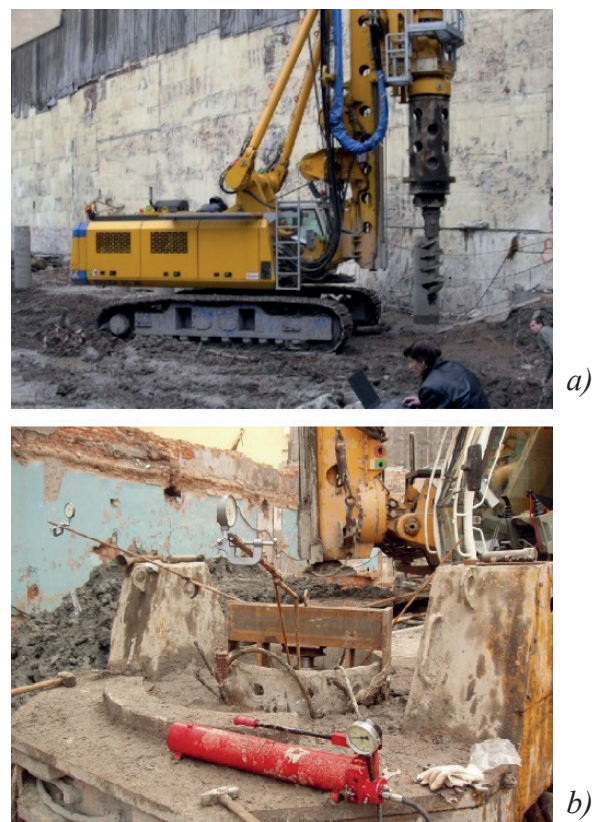
Figure 5a shows a picture of the process of measuring vibrations of the walls of the surrounding buildings. The taken measurements of the vibration acceleration in the load-bearing structures of the buildings allowed establishing, in particular, that the process of underpinning the foundations and ground beds is safe, according to the technology applied, for the walls of the building, and that it was not acceptable to use more than one drilling rig at a time on the construction site. At the simultaneous operation of two and more self-propelled drilling rigs of the BG 25 type, the measured vibration acceleration in the building walls

Figure 5. The complex science investigations on the construction site: taking vibration measurements during the construction of drilled cast-in-situ piles (a); the stamp test of the soil on the bottom pile's level (b).

exceeded the maximum permissible values b) and might cause the structures to be destroyed.

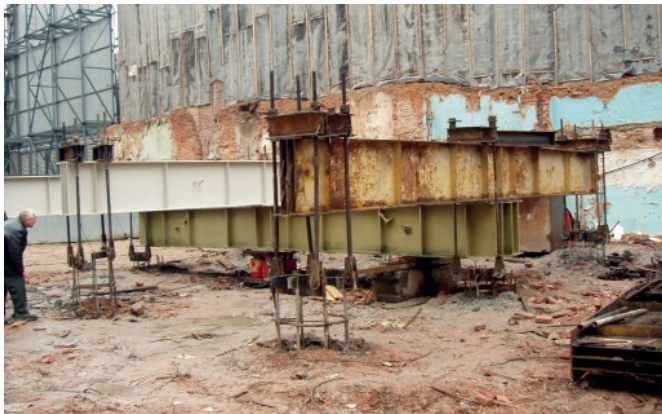
Prior to starting the mass construction of the drilled cast-in-situ piles, the static tests were carried out on test piles, and the tests showed that their load-carrying capacity was at least 2000 kN, which is considerably higher than their design load (Figure 6).

Figure 6. Static tests of piles using hydraulic jacks

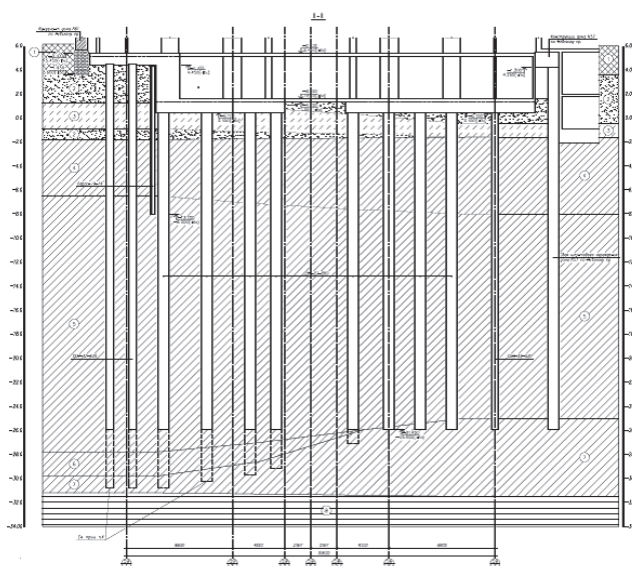
Figure 7. The cross section of the basement and piles with the difference depth according of the level bearing capacity soils.

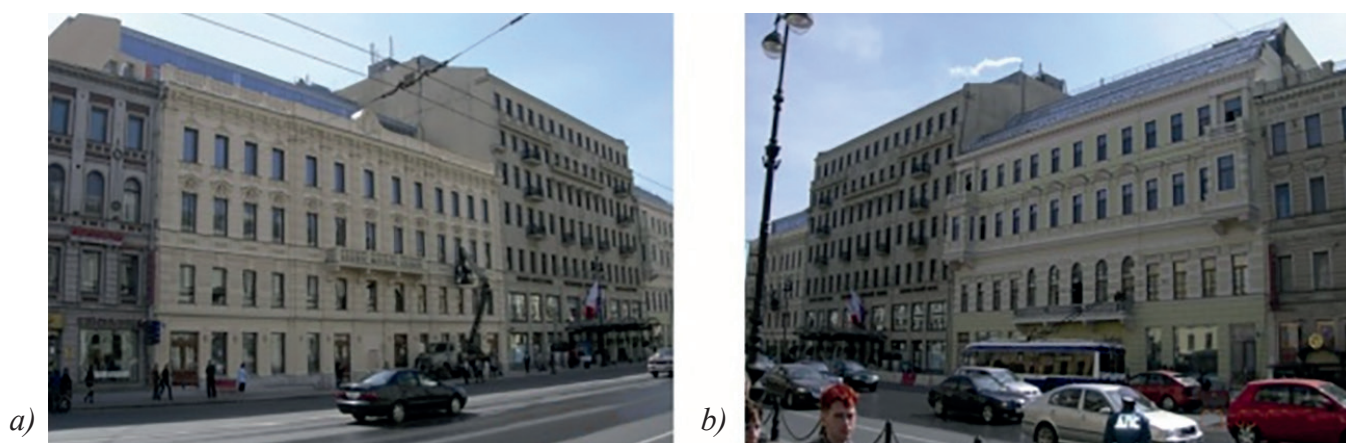
At the end of May 2009, the new Hotel buildings were successfully commissioned (Figure 9).

Figure 9. New buildings of Corinthia Nevsky Palace Hotel: a – Building No. 59; b – Building No. 55
