## INVESTIGATION OF FAILURE OF RIVERBANK PROTECTION STRUCTURE: A CASE STUDY IN LONG AN PROVINCE, VIETNAM

*Pham Ngoc Thinh, Dang Van Phu*

Thuyloi University, 175 Tay Son, Dong Da, Hanoi, VIETNAM

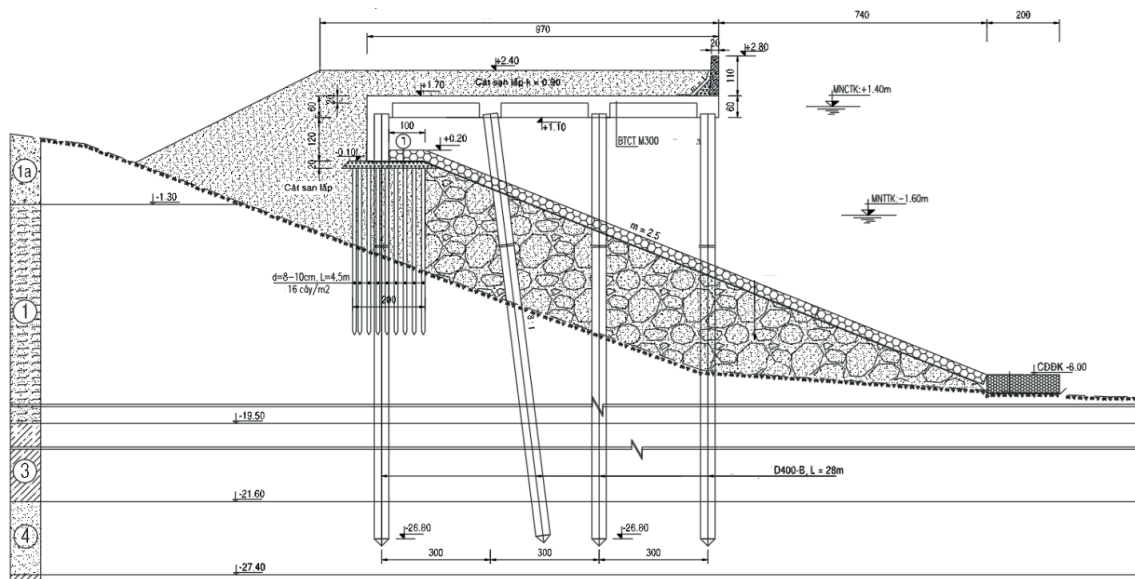
*Figure 2. Long Hau embankment cross-section*

As shown in Fig. 2, this riverbank protection structure consists of a reinforced concrete retaining wall approximately 1.1 meters high and an average thickness of 20 cm. The retaining wall is designed to withstand significant lateral forces exerted by the river, especially during rainy seasons. Behind the wall, a compacted sand layer with a compactness  $K$  of 90% provides a support layer to minimize movement and displacement by evenly distributing the pressure load on the retaining wall. The retaining wall is connected to a series of 400 mm diameter and 28 m long prestressed concrete piles, which form the foundation of the structure, ensuring both vertical and horizontal stability. The piles are arranged in a grid pattern, with 3.0 m spacing both vertically and horizontally, each sector consisting of two vertical piles and one inclined pile. This configuration is intended to maximize load distribution and to counteract forces caused by land subsidence, flow, and sediment movement.

The foundation of the structure is reinforced with a layer of geotextile fabric under the sand layer to increase stability and prevent erosion phenomena, along with a series of tightly packed PVC-coated gabions at a depth of -6 meters along the riverbed. These gabions, dimensions of 200 cm x 100 cm x 50 cm, act as a protective barrier against erosion, creating a buffer zone that protects the foundations from direct hydrodynamic impact.

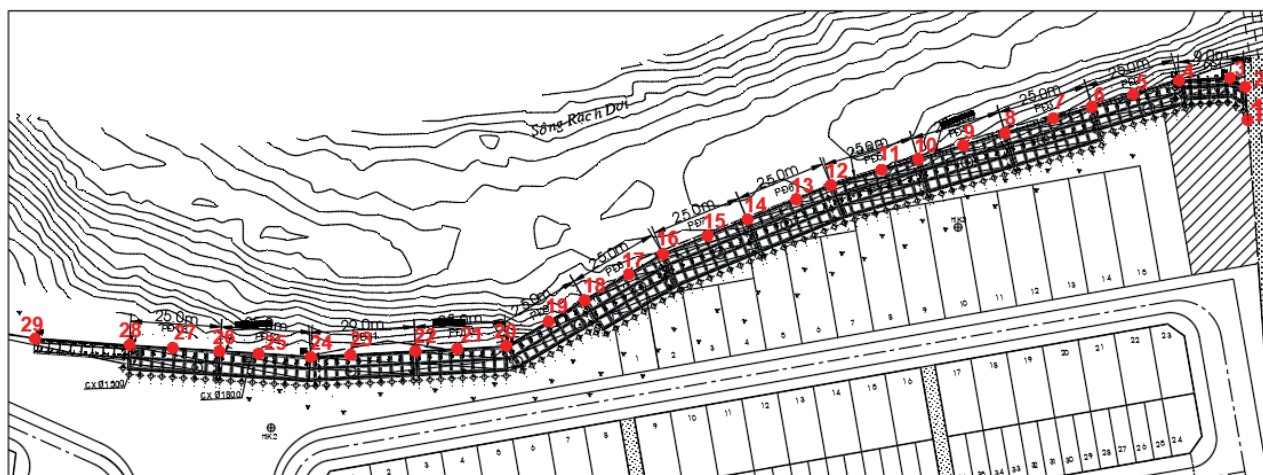
Figure 6. Locations for displacement observation

The field observation, which took place from August to September 2023, included 29 specific locations illustrated by the red area in Figure 5 and the red spot illustrated explicitly in Figure 6. The main objective of the observation was to systematically collect and observe at each location after the backfilling work, thereby assessing the actual condition of the project during construction. From there, it is possible to assess the safety level or detect the damage of the Long Hau embankment project.

The results collected from the field observation have been summarized and presented in Fig.7. It can be seen that, after the backfilling on August 16, 2023, the project experienced displacement at 29 measurement points for the first observation. Especially at positions 10-16, the displacement value is quite large, about 11-16cm. After that, there were 10 more observations and the displacement value continued to increase to about 20cm for measurement positions 12 and 13. In addition, cracks have gradually appeared on the concrete piles and can cause unsafety for the project. From this, it can be seen that the design

and construction work were not proper when not fully assessing the impact of backfilling on the project. This displacement may be due to horizontal soil pressure as well as the increased load of machinery and equipment during the backfilling process. In addition, the displacement is great at positions 10-16 due to the considerable area of backfilling compared to the other positions. Thus, the impact of the lateral active earth pressure at these positions is more significant. To verify the cause of this problem, numerical simulation analysis needs to be performed, as shown in the following section.

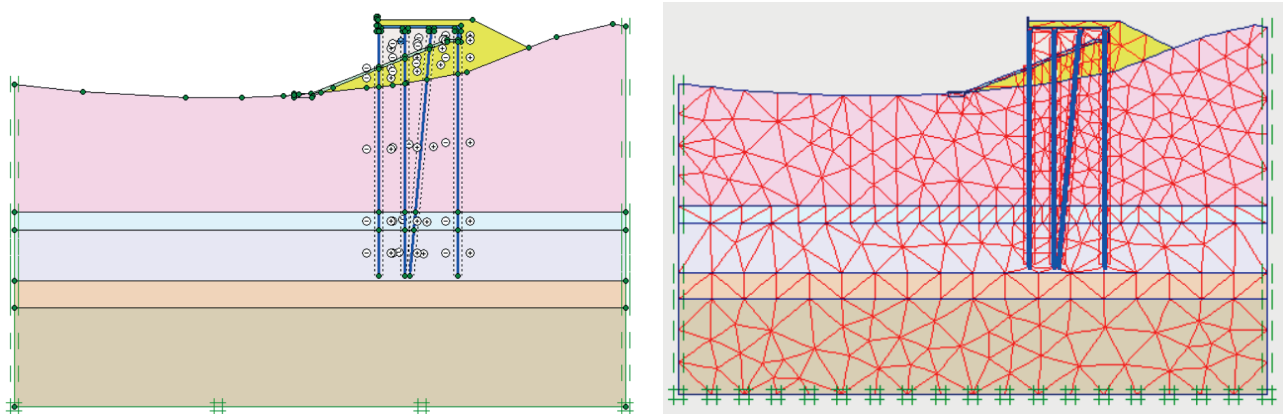
*Figure 8. Numerical analysis in Plaxis 2D*

Numerical analysis is widely employed to solve the engineering problem by various researchers [15, 16]. In this study, PLAXIS 2D software – a tool widely used by engineers and researchers to solve geotechnical problems [17, 18, 19] – was applied as a design tool to analyze the stability and determine the cause of geotechnical failures. The mechanical properties of the embankment together with the geotechnical properties of the embankment and foundation, were collected for analysis using the finite element method. To ensure the accuracy of the simulation, the boundary conditions were specifically set as follows: the bottom of the model was assumed to be completely fixed (fixed boundary), while the longitudinal boundaries only allowed vertical displacement to reflect the actual conditions at the site, as shown in Fig. 8.

The soil parts are modeled using six-node triangular isoperimetric elements with three Gaussian points per element as presented in Fig. 8. The Mohr-Coulomb (MC) model, an elastic-plastic model commonly used to simulate the general behavior of soils, requires five parameters: Young's modulus ( $E'$ ), friction angle ( $\phi'$ ), Poisson's ratio ( $\nu'$ ), cohesion ( $c'$ ),

The connection between the embankment and the filling soil was also taken into account in the analysis by the rectangular interface elements, which consist of six nodes used between the soils and the structural elements [21]. The material properties used in the finite element simulation are detailed in Tables 1 and 2.
